Re: Green Garden Township
25506 S. Center Road, Monee, Illinois 60449
Architect's Project Number: 23-075
Existing Facility Report

On October 26, 2023, Tria Architecture and Larson Engineering performed a visual survey of the existing Township owned facility at 25506 S. Center Road, Monee, Illinois 60449. No destructive testing or testing of materials on site was performed at this time. The results given below are based solely upon this visual survey. While we understand that it is the intent of the Township to remove the existing barn structure, in the interest of a complete facility survey our team completed a visual survey of the barn as well as the main building and have included both in this report.

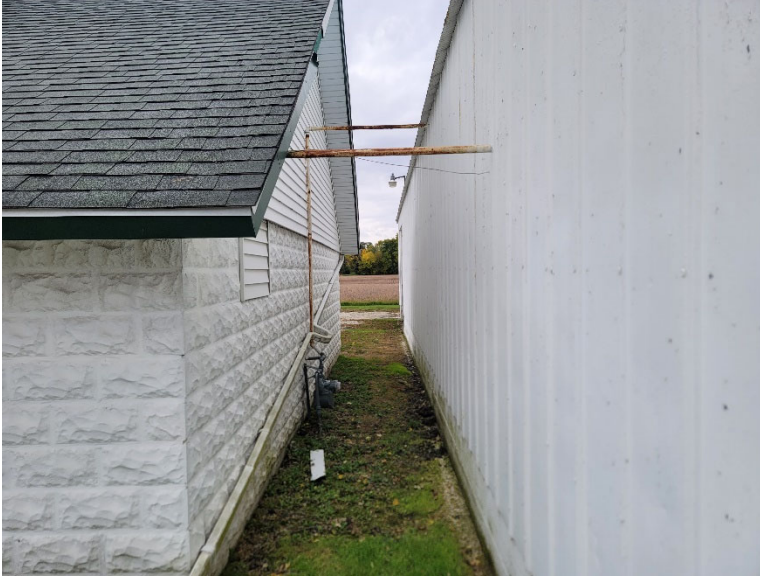
Figure 1 Space between Barn and Main Building

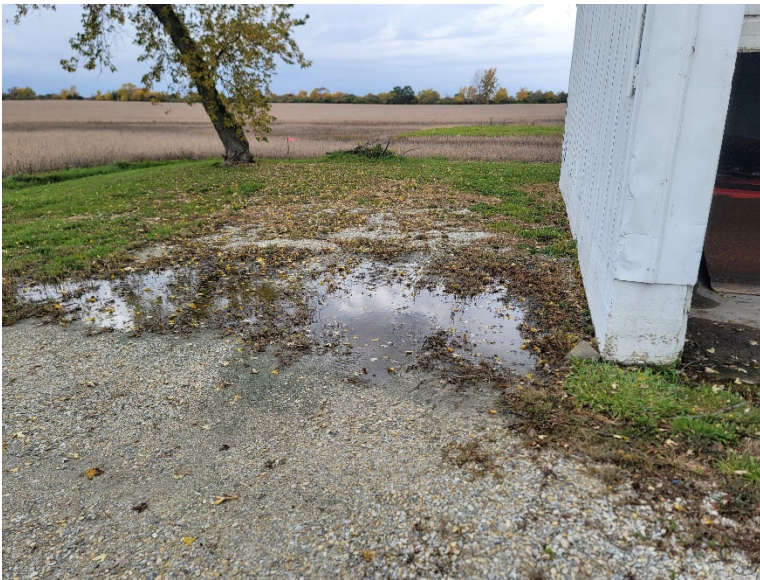
Figure 2 Ponding of water adjacent to Barn

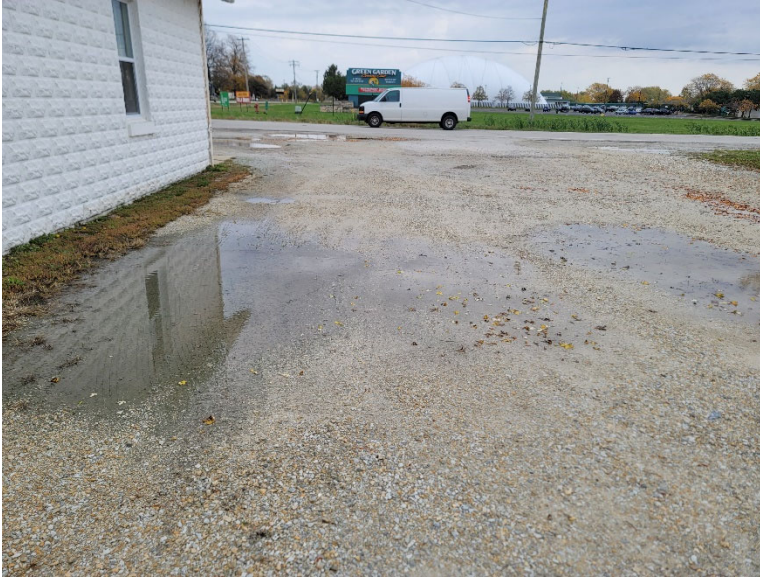
Figure 3 Ponding of water in parking lot

It is recommended to relocate the septic system to allow for paving of the parking lot and to relocate the tank access so it is not in the parking area.

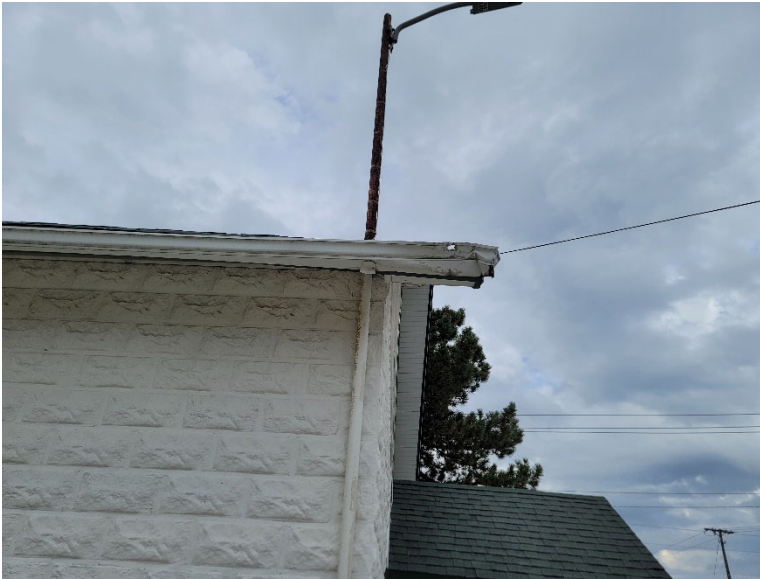
The main building roof is in good condition. A section of gutter has been damaged and some trim/flashing elements are missing or damaged.

Figure 4 Damaged gutter

Replace damaged or missing trim/flashing elements and replace the damaged section of gutter.

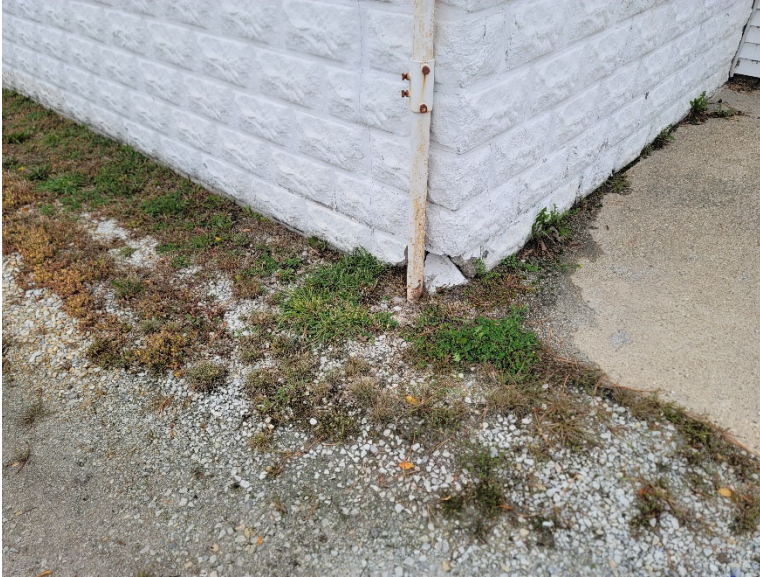
At the main building, there are areas of mortar joint cracking, a corner with more severe masonry cracking and two locations of damaged masonry units. No insulation was observed in the wall system.

Figure 5 Damaged masonry

The masonry around the main building needs to be tuckpointed where cracks exist, and damaged units replaced. The failing paint should be removed and repainted. Insulation should be added to the exterior wall system where none currently exists.

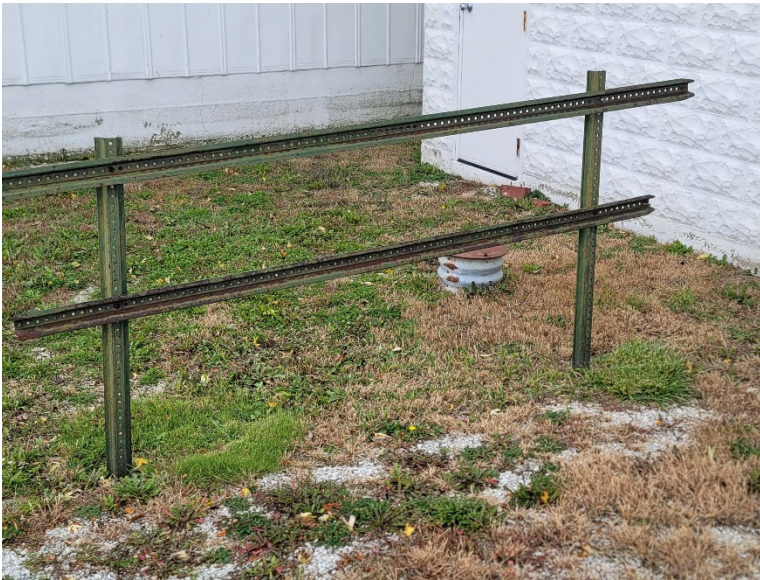
The well and septic systems are located below grade and could not be visually inspected while on site. The well and septic systems should be inspected by a reputable company to determine whether they are in good condition.

Figure 6 Septic tank cover

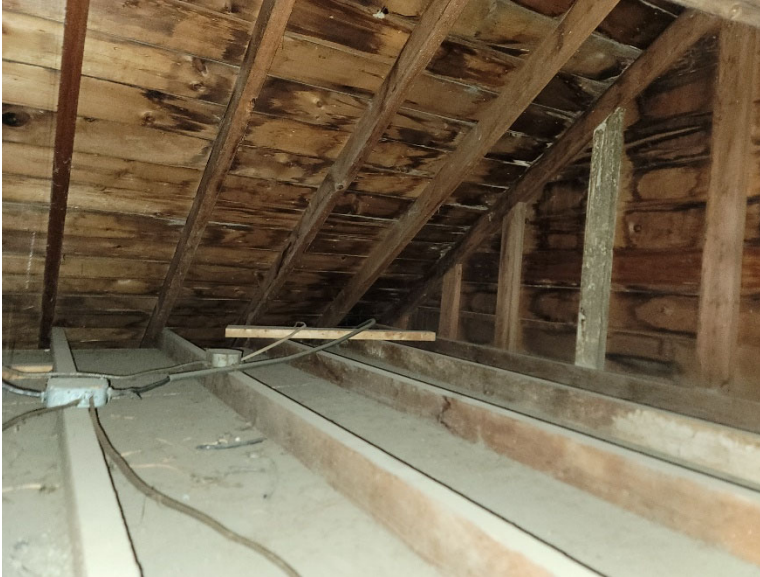
The Community Room is finished with wood wall paneling and hard wood flooring. The exposed SAT ceiling is hung below an older 12x12 tile ceiling with the original panel ceiling finish attached to the underside of the roof joists above that. No roof or ceiling insulation is visible at the rear of the building.

Figure 7 Area above rear portion of building

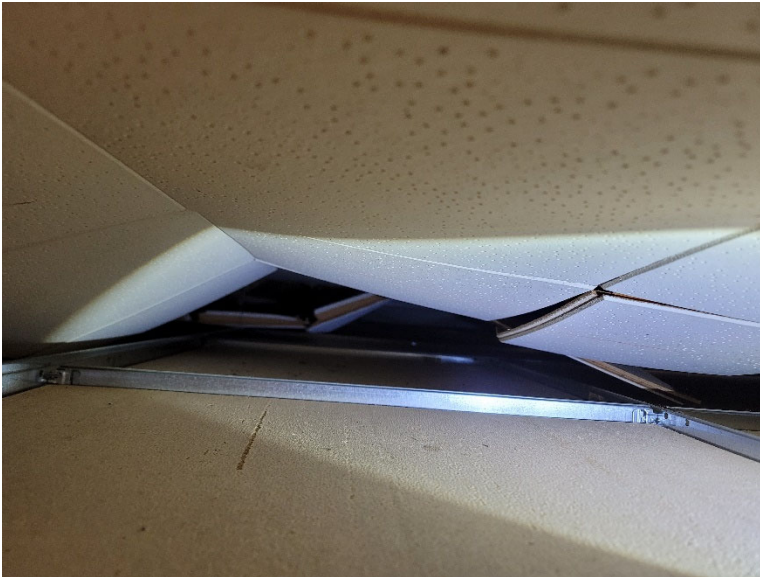
The wood floor in the Community Room is worn and scratched in many areas. The 12x12 tile ceiling above the SAT ceiling is older and has collapsed in several areas. The original panel ceiling on the rafters appears to be intact but access to the above ceiling space was very limited.

Figure 8 Area above Community Room ceiling

The 12x12 ceiling above the SAT in the Community Room needs to be removed to prevent further collapse and damage to the SAT ceiling below. The wood

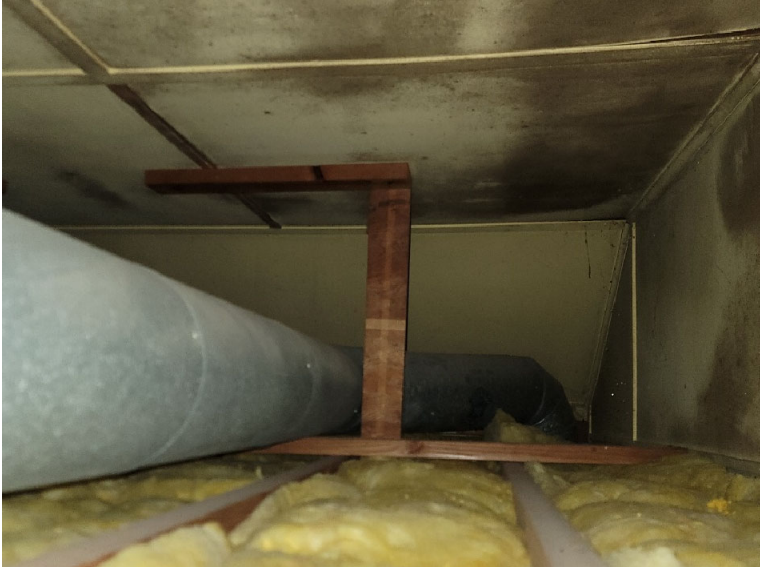
Figure 9 Original panel ceiling on roof joists

All 12x12 ceiling tiles should be tested as well as the panel ceiling attached to the rafters.
